BUILDING CONDITION ASSESSMENT

519 DURHAM REGIONAL ROAD 8, UXBRIDGE

November 10, 2022

Project No. 22tA048A

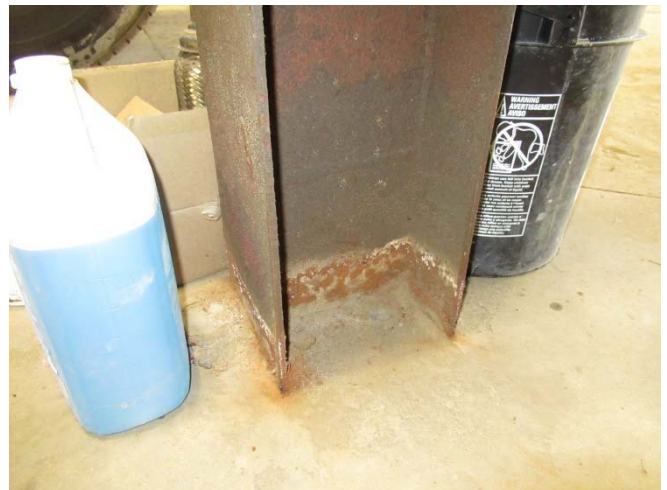
Corrosion was noted at the base of numerous structural steel members. There is also freeze-thaw damage (scaling) at the base of the concrete block walls. Both conditions are a result of repeated wetting over the building's service life exacerbated by exposure to de-icing salts.

Photo 2: Corrosion at the base of a column.

Impact damage to the columns at the centre of the east room was also noted, most likely caused by vehicle impact. Further analysis is required to confirm the exact repair requirements. Pending this, we have included a preliminary budget to repair the impact damage. The budget allocated also includes an allowance for repairing the worst areas of scaling on the concrete block walls.

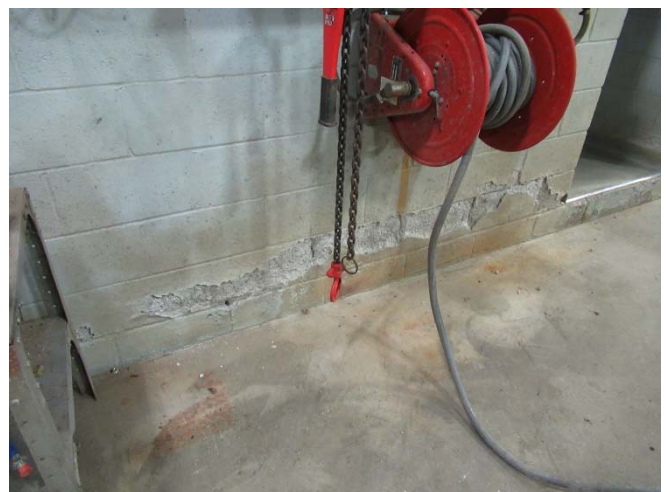
Photo 3: Scaling at the base of a concrete block wall.

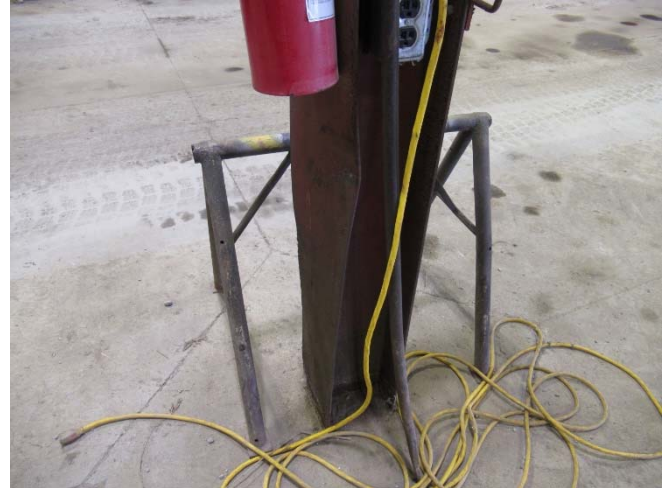
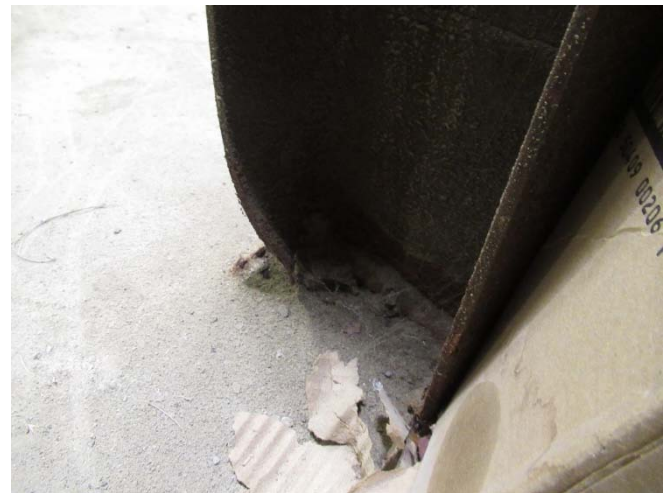
Photo 4: Impact damage to a steel column.

Description	Classification	Present Cost	Timing (Year)	Cycle (Years)
Repair Columns and Concrete Block Walls (Preliminary)	3	\$150,000	2023	N/A

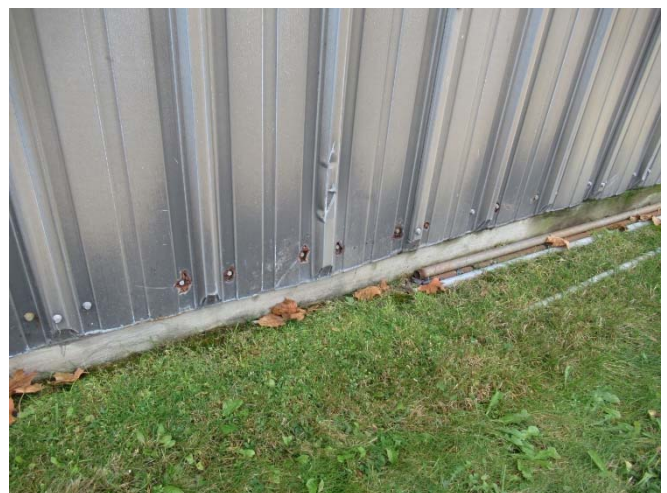
- localized failed sealants;
- some missing/loose fasteners and flashings;
- localized deteriorated mortar joints;
- some corrosion and impact damage to the sheet metal cladding; and
- faded finish on sheet metal cladding on the east and north elevations.

Photo 8: Corrosion and impact damage at bottom of metal cladding on the north elevation.

While most of these conditions do not require immediate attention, we have included periodic allowances within the reporting term to complete repairs to the exterior walls, including localized sealant, fastener replacement, localized block replacement and repointing deteriorated/missing mortar joints, and localized sheet metal repairs.

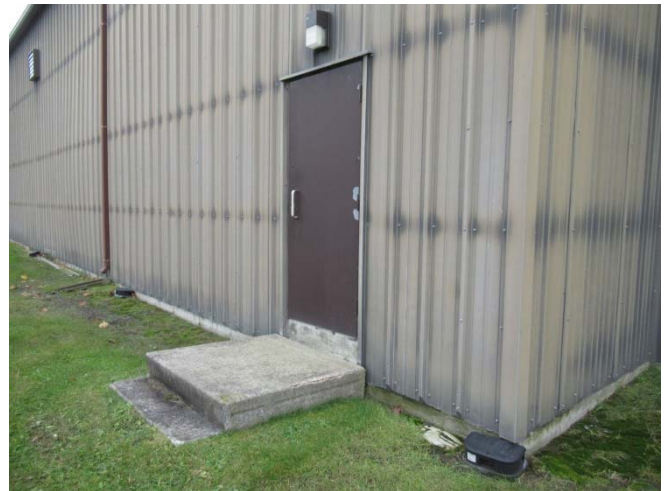
The swing doors generally did not self-close and there was corrosion at the base of some door frames. We assume that repairs and replacement of individual doors will be managed on an as-needed basis funded out of operating budgets. As such, no capital expenditures have been included.

Photo 10: Typical swing door.

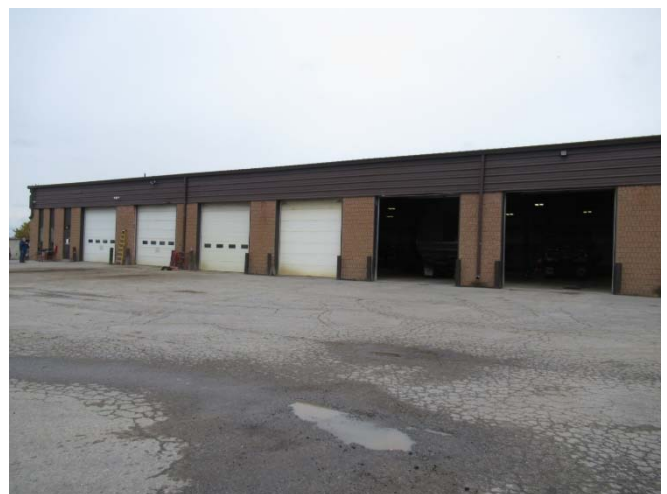
We were not made aware of any issues with the operation of the overhead doors. The doors have reportedly been periodically replaced over the last ten years with two original doors remaining. We have budgeted for replacement of the original overhead doors and operators as they have reached the end of their service life. We have

Photo 11: Typical overhead doors.

also included a periodic allowance for overhead door and operator replacement which accounts for two doors/operators every three years.

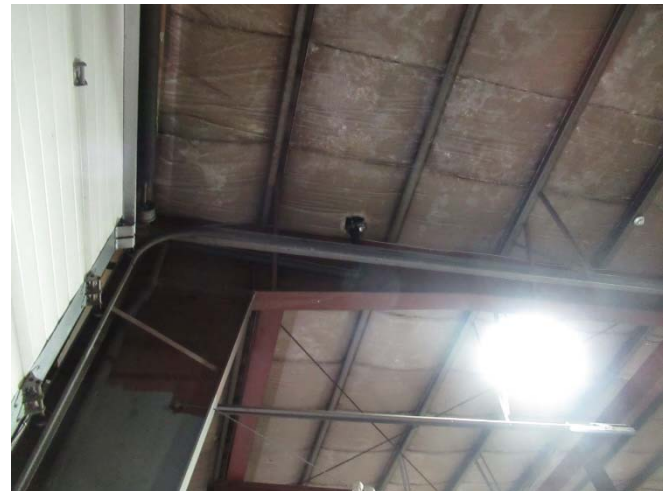
Based on discussion with site staff, we understand that there is currently a leak at a roof penetration near an overhead door. We expect this will be addressed as part of the upcoming restoration project which also includes localized sheet metal repairs, applying a fluid-applied coating over the existing metal roofing and replacing the eavestrough leaf guard.

Photo 13: Reported roof leak location.

Description	Classification	Present Cost	Timing (Year)	Cycle (Years)
Restore Metal Roof	3	\$265,000	2022	20

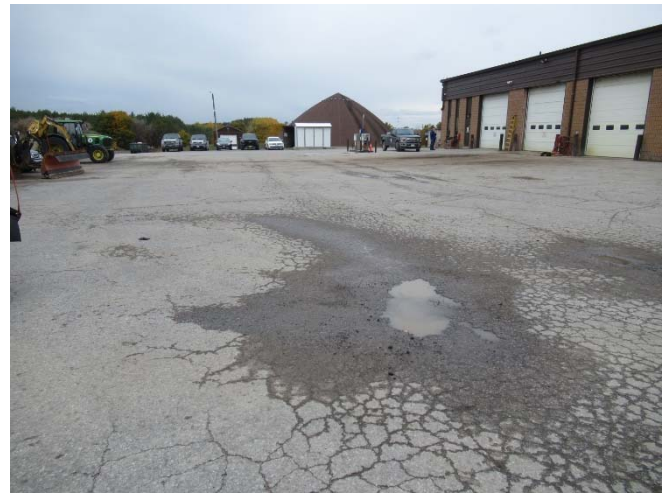
The asphalt pavement is serviceable but generally in poor condition. There are potholes, alligator cracks, sections of missing pavement and water ponding throughout. Given the current extent of deterioration, we have carried a budget as provided by the Town for replacing the asphalt paving, in the short-term. This work is scheduled to be completed after the replacement of the sand dome (see the Section 8 *Out-Buildings* portion of this report for further information).

Photo 16: Asphalt pavement.

Description	Classification	Present Cost	Timing (Year)	Cycle (Years)
Replace Asphalt Pavement (Phased)	3	\$250,000	2026 2027	20
Replace Chain Link Fencing	3	\$75,000	2028	35

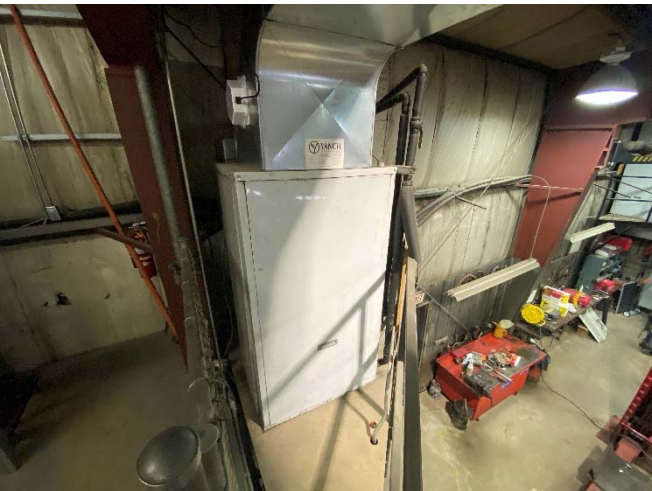
According to Management, the heat pumps are in poor condition and the Town is in the process of obtaining quotes for their replacement. We understand the 3 ton unit is being replaced immediately and the two 6 ton units may be replaced within the next year. We have included projects in the capital plan based on the quote provided.

Photo 18: 6 ton ground source heat pump unit.

Description	Classification	Present Cost	Timing (Year)	Cycle (Years)
Replace 3 Ton GSHP	3	\$19,000	2022	25
Replace Two 6 Ton GSHPs	3	\$43,400	2023	25

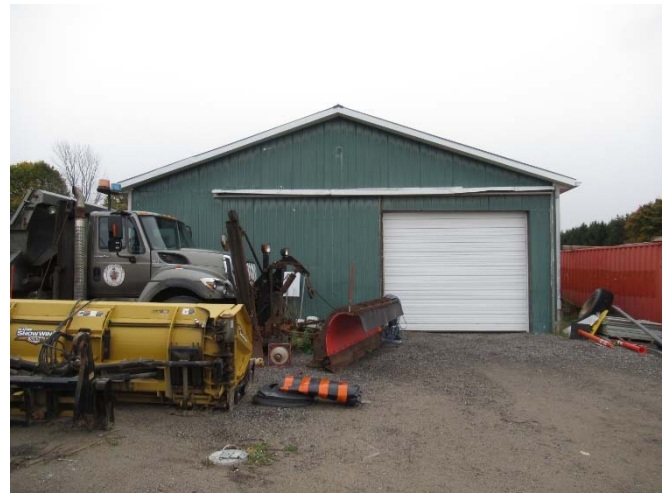
The sheet metal cladding is faded and there is minor impact damage.

Photo 26: Sign shed exterior.

Localized repairs to the cladding are expected to be addressed out of the exterior wall repair allowance (see the *Exterior Walls* section of this report for further details).

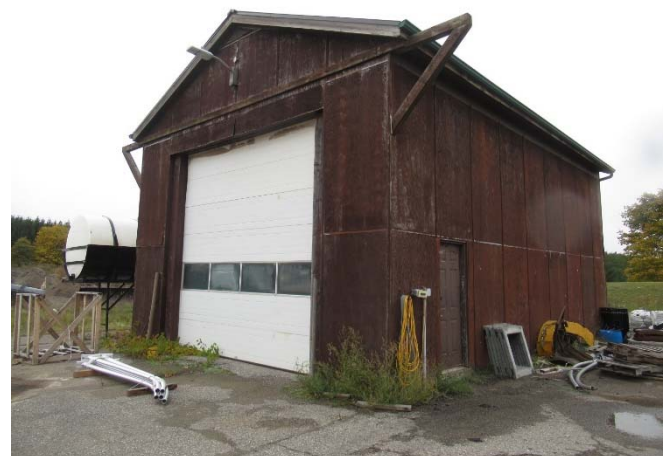
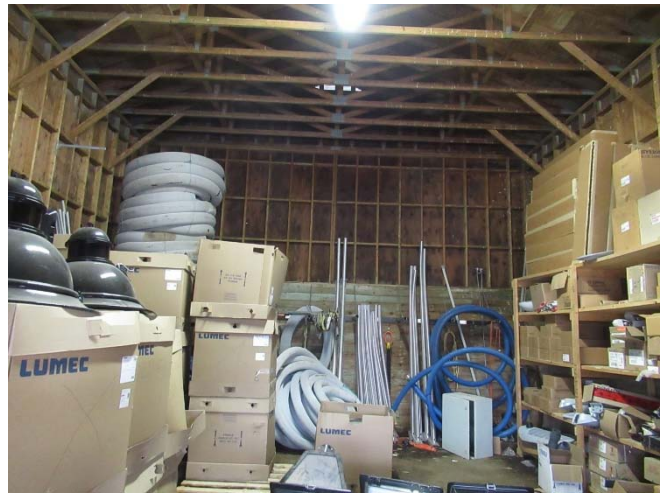
There was water staining on the interior walls and the wood cladding was generally weathered.

We have included a budget to re-clad the salt shed as the wood cladding is heavily weathered and there is evidence of leakage on the interior.

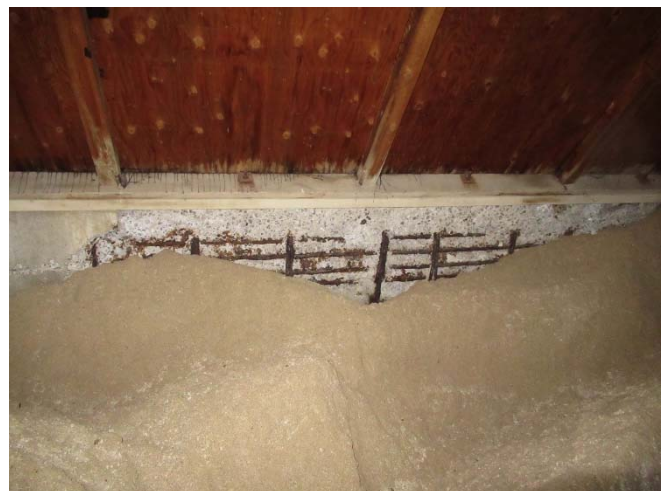
Most of the interior face of the foundation walls was concealed below-grade and by stored materials (sand). In the visible areas, the concrete is extensively delaminated (corrosion damaged) and there are large areas of exposed and heavily corroded reinforcing steel.

Photo 31: Delaminated (corrosion damaged) sand dome concrete foundation walls with exposed reinforcing steel.

Replace Wood Cladding on Salt Shed	3	\$50,000	2025	25
Design New Salt Dome	4	\$30,000	2023	50
Demolish and Replace Salt Dome (Preliminary)	4	\$300,000	2024	50
