Corporation of the Township of Uxbridge

**Structural Re-inspection
Uxbridge Music Hall**

**16 Main Street S,
Uxbridge, Ontario**

February 2024

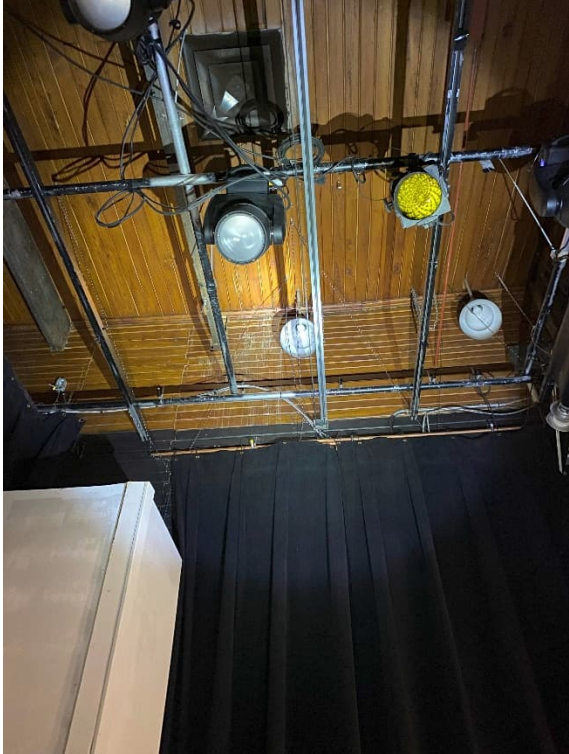
1. A visual inspection of the underside of the ceiling was conducted from the mezzanine level. Prominent leaking stains are noticeable on the ceiling, particularly along the sloped area beneath the chimney on the north side, and adjacent to the junction of the lower roof and main roof on both the south and north sides. Signs of water leakage are also evident near the first window from the northeast corner of the ceiling. (see Photo 1 to 3)

Photo 1: Water Stains near the Junction of Lower Roof and Main Roof

1. Large gaps exist between the roof planks. The roof membrane above these gaps is unsupported, which leads to water infiltration and pre-mature membrane damage. To mitigate water leakage, it is recommended to apply a layer of ½" plywood over the existing wooden planks to cover the gaps when re-roofing the building. If opting for a replacement of the current shingle roof with metal sheathing, plywood is optional. It is advised to conduct the re-roofing promptly to minimize water penetration.
2. The two chimneys near the lower roof are no longer in use. Portion of the chimneys (from the ground floor to the underside of the ceiling) were previously removed but the upper portion (above the ceiling) remain. The area surrounding the chimneys appears to be a primary source of roof leakage. Therefore, it is

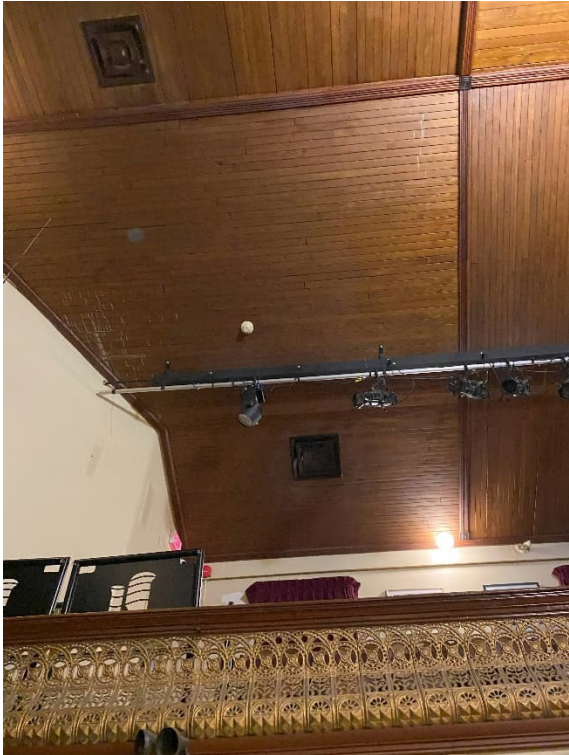
8. An inspection of the full height basement was conducted during the site visit, revealing no apparent signs of structural concerns.
9. The two chimneys near the lower roof are no longer in use. Portion of the chimneys (from the ground floor to the underside of the ceiling) were previously removed but the upper portion (above the ceiling) still remain. Heavy water stain was observed along the surface of the chimney brick within the attic space.

Photo 2: Water Stains beneath the North Chimney

recommended that these two chimneys be completely removed and the roof patched to match adjacent areas.

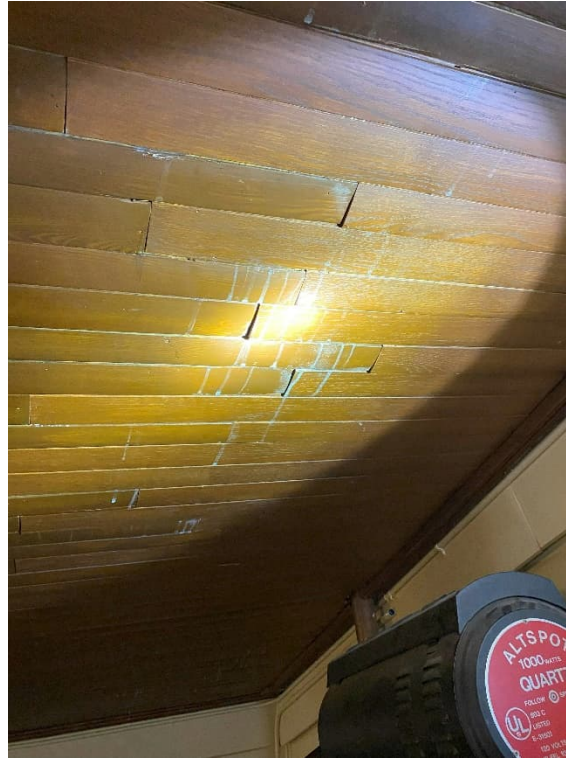
Photo 3: Water Stains near the First Window from the Northeast Corner

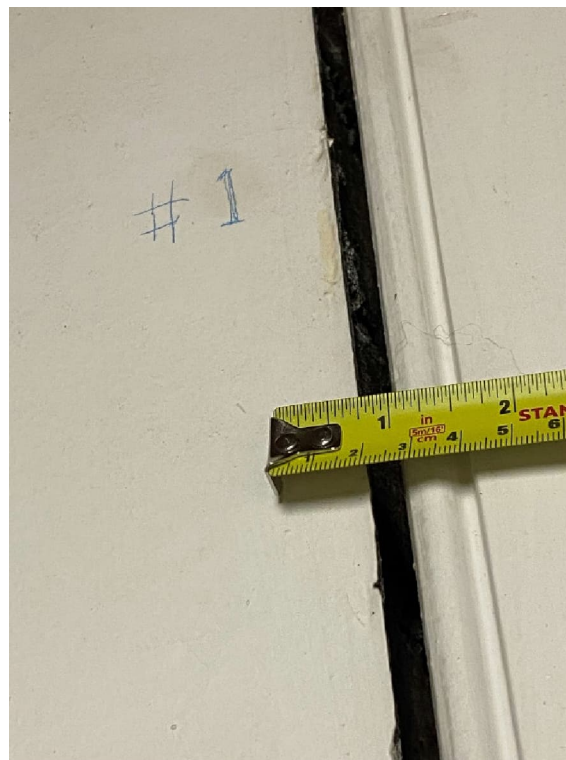
2. Cracks on the walls in the control room were measured during the site visit. Despite the absence of monitoring devices since October 2017, these measurements and photos have been compared with the records from 2017 to determine whether the cracks have been progressively worsening over time. (see Photo 4 to 8)

Photo 4: Measurement at Monitor Point #1

3. Regarding the existing wall cracks in the electrical room, the measurements taken during this inspection were compared with the past records from 2017. No significant changes in the gaps were observed. It is recommended to monitor them regularly. If there is further structural movement or new wall cracks observed, please report to us for future investigation or monitoring.

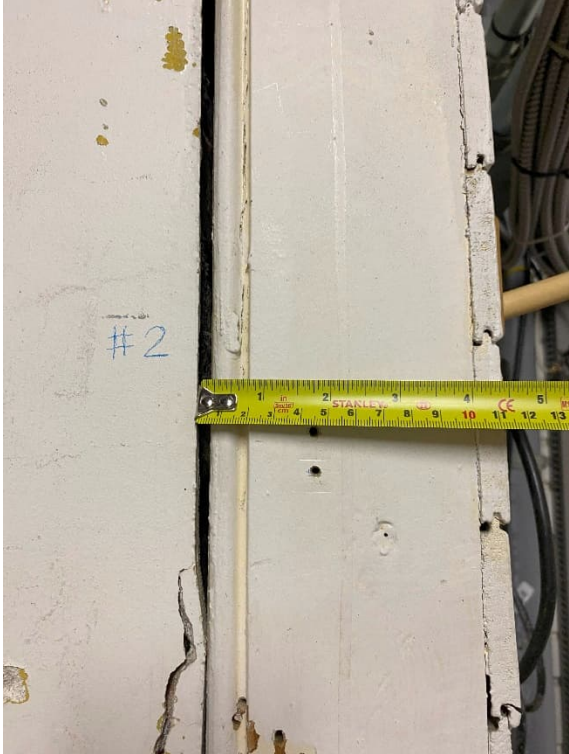
Photo 5: Measurement at Monitor Point #2

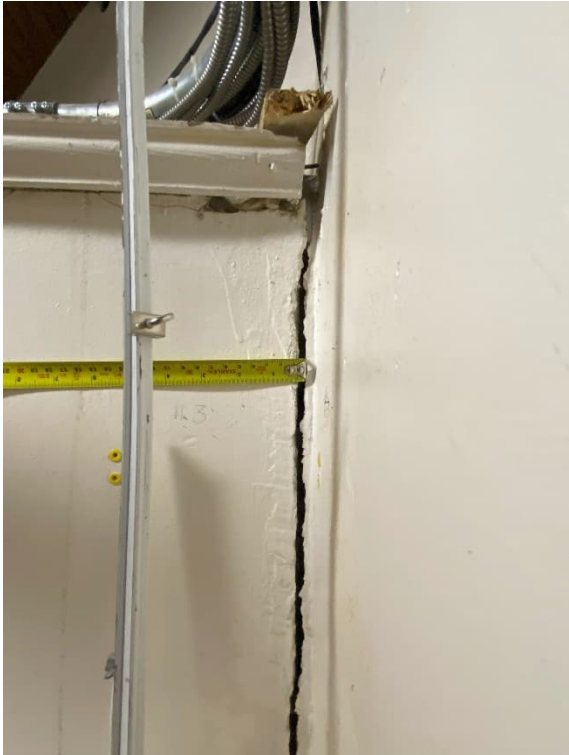
Photo 6: Measurement at Monitor Point #3

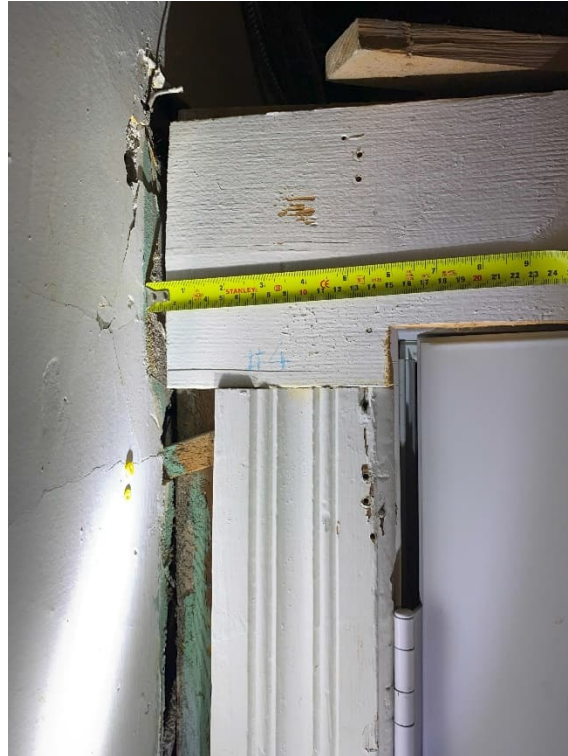
Photo 7: Measurement at Monitor Point #4

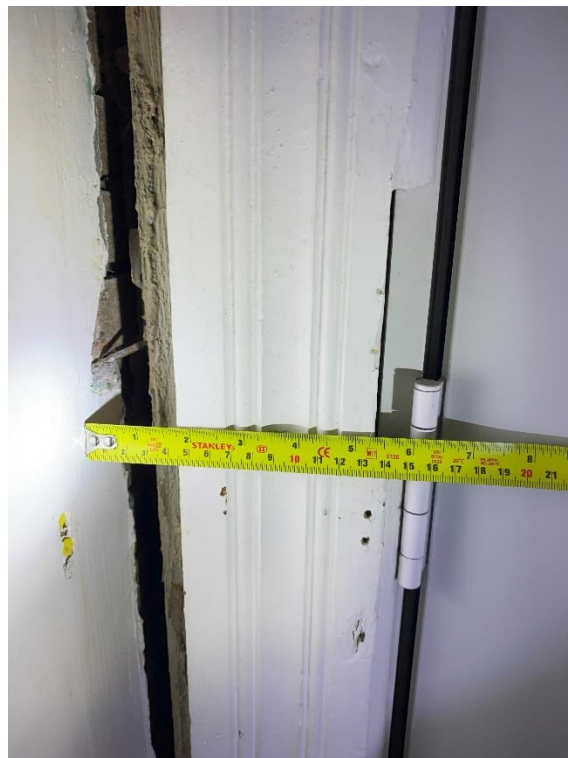
Photo 8: Measurement at Monitor Point #5

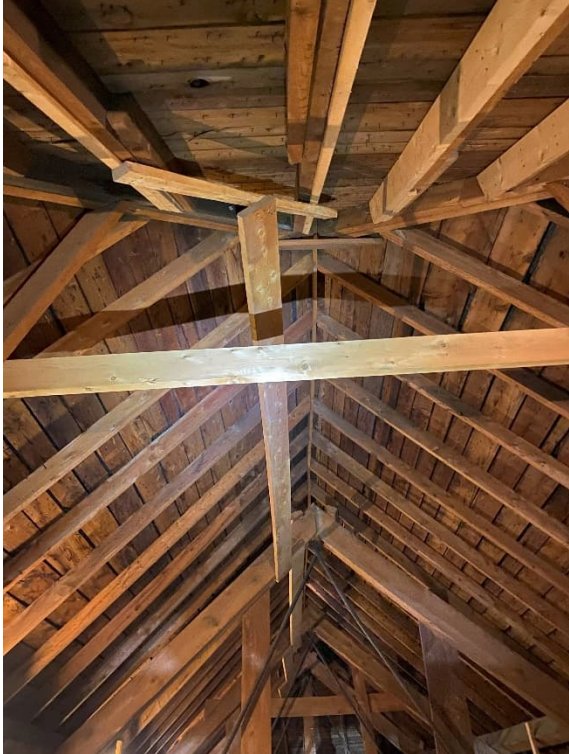
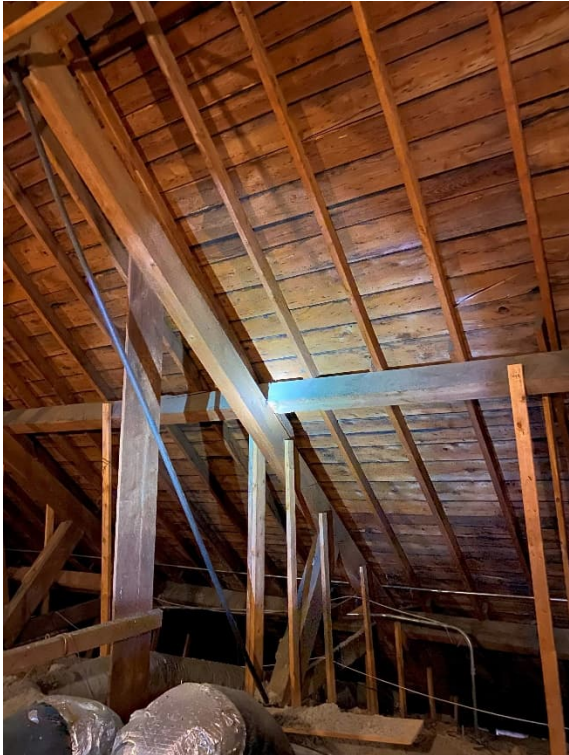
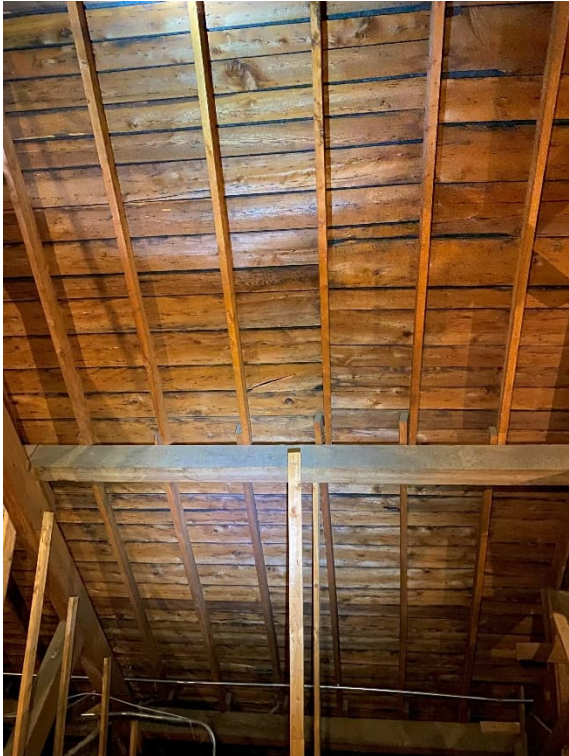
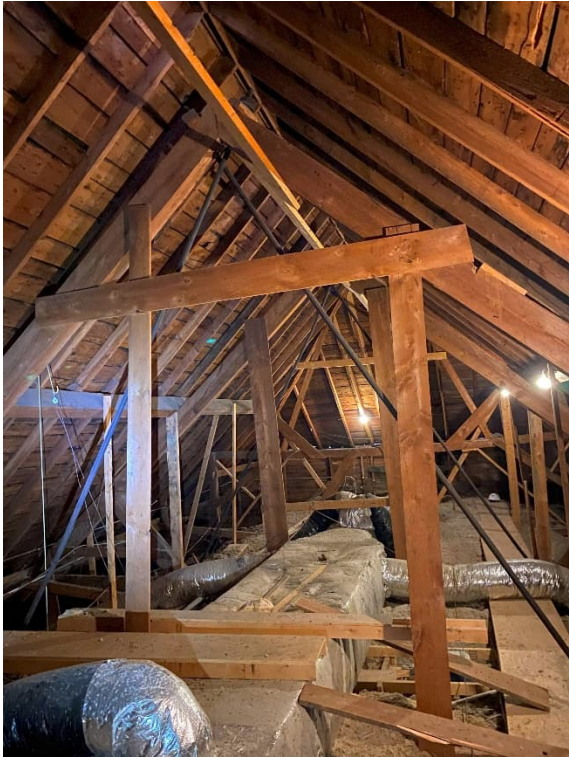
3. The attic was accessible and can be walked inside to assess the condition. The timber main trusses, roof beams between the trusses, and rafters were found to be in fair to good condition, with no significant cracks or chippings observed. (see Photo 9 to 12) However, water stains at the underside of roof planks were observed at many locations, some of the roof planks displayed splitting and cracking. Large gaps between roof planks exist at many locations. Waterproofing membrane above the gaps area visible from underneath. The largest observed gap between wooden planks measures approximately 3 inches. (see Photo 13 to 16)

Photo 9: Trusses and Rafters in the Attic (Main Roof)

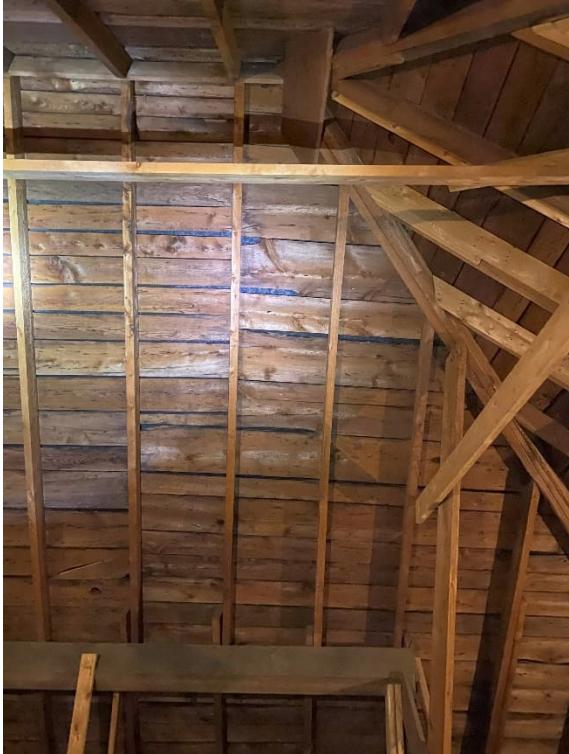
Photo 13: Splitting Wooden Planks at Main Roof

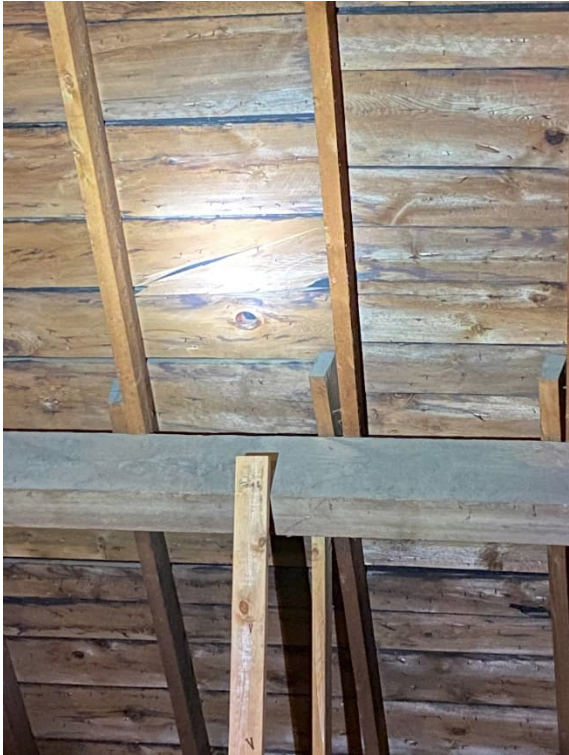
Photo 14: Splitting Wooden Planks at Main Roof

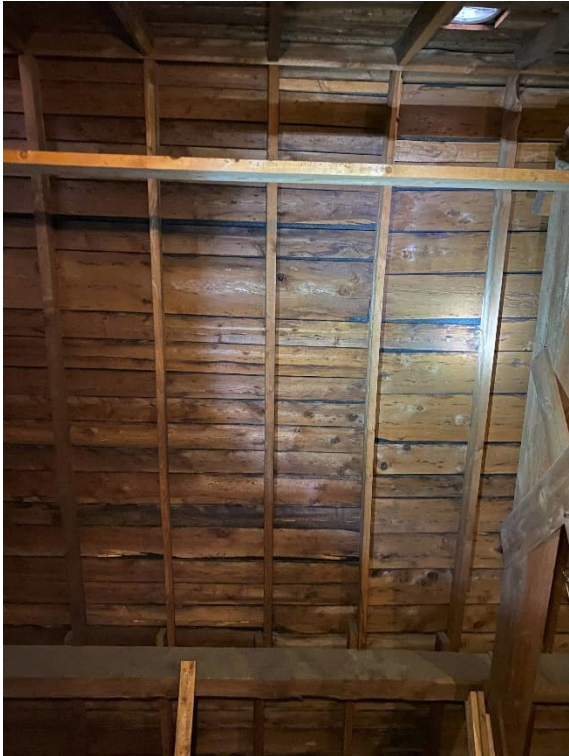
Photo 15: Gaps between the Wooden Planks at Main Roof

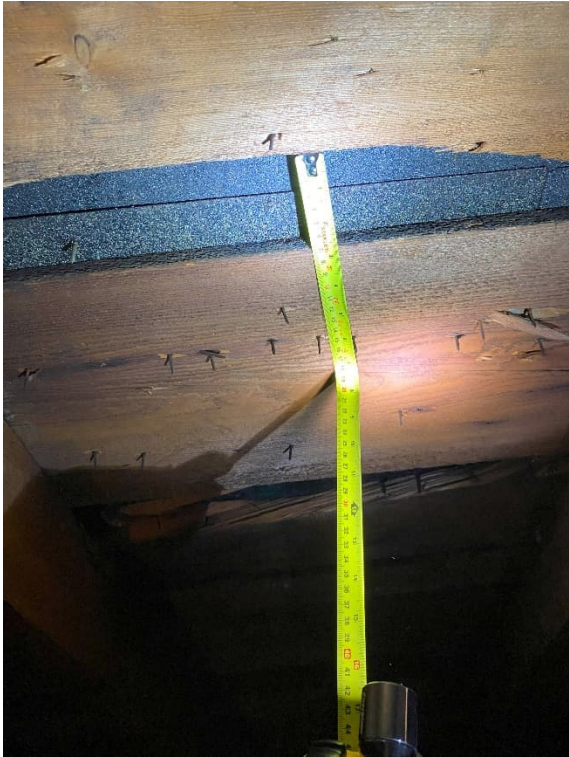
Photo 16: Measurement from One of the Largest Gaps

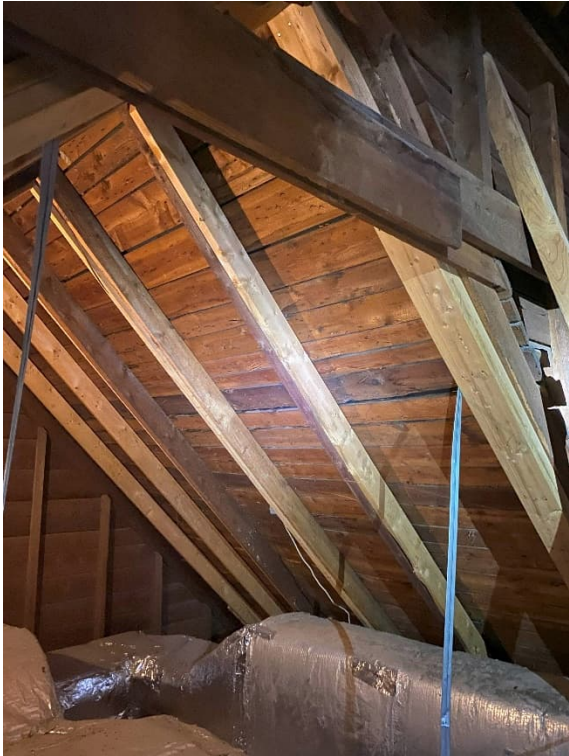
4. Some of the rafters supporting the lower roof were found to have been cut to accommodate the air ducts. When observing from outside, significant unevenness and sagging were evident on the lower roof from both the north and south sides. (see Photo 17 to 20)

Photo 17: Rafters in the Attic (Low Roof)

4. The notched rafters at the lower roof lack adequate strength and lead to increased deflections and should be repaired by installing doublers. It is recommended to reinforce the rafters of the lower roof by adding another 2x6 lumber at each existing rafter. This reinforcement should enhance the roof's loading capacity and help prevent the development of roof unevenness.

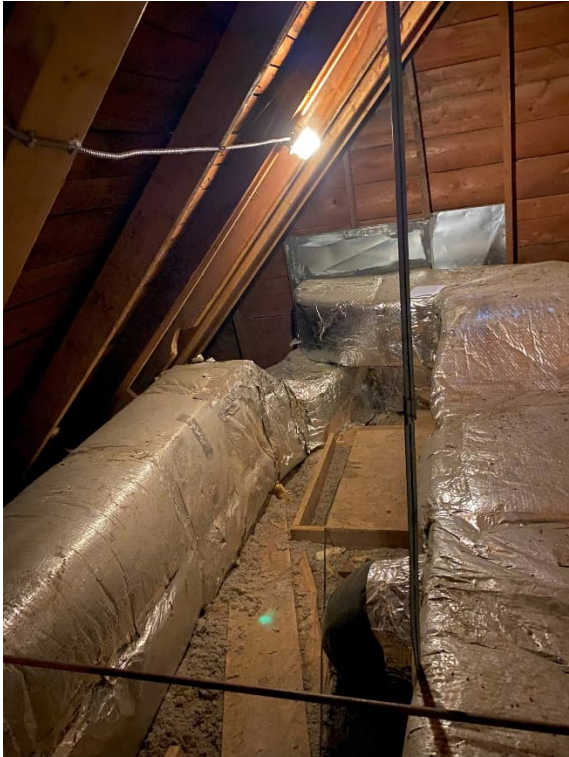
Photo 18: Notched Rafter in the Attic (Low Roof)

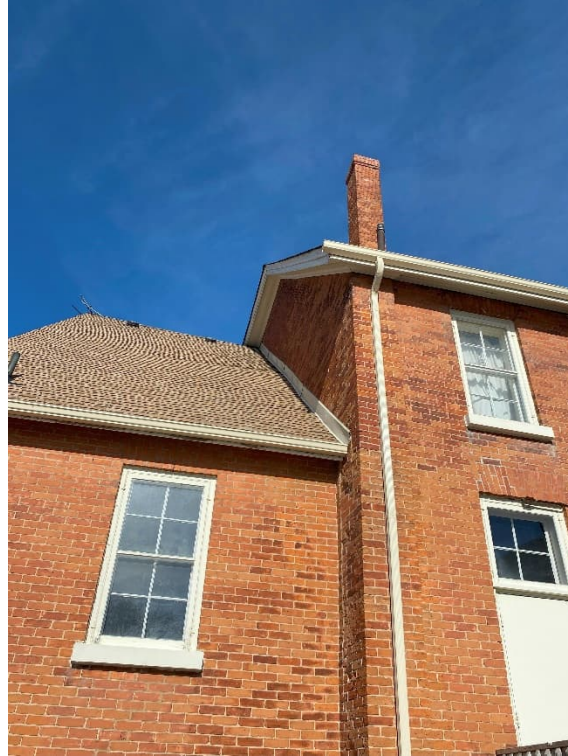
Photo 19: Observing Low Roof from Outside

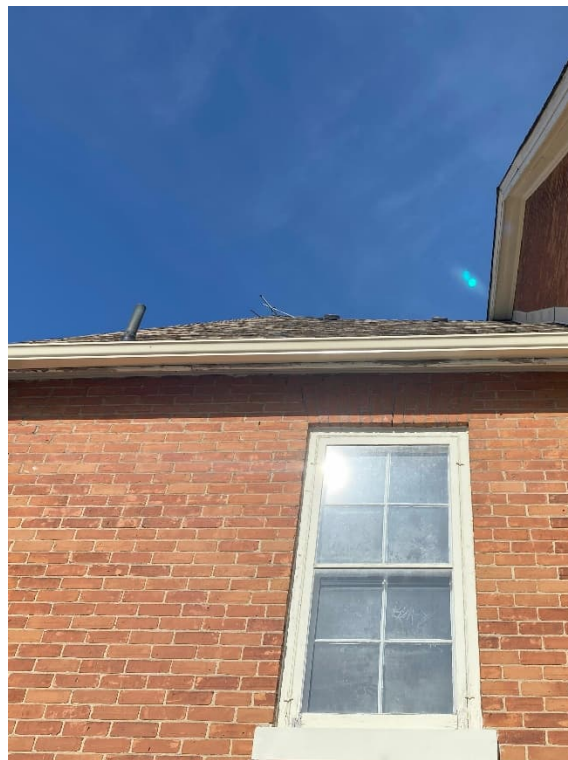
Photo 20: Unevenness on Low Roof

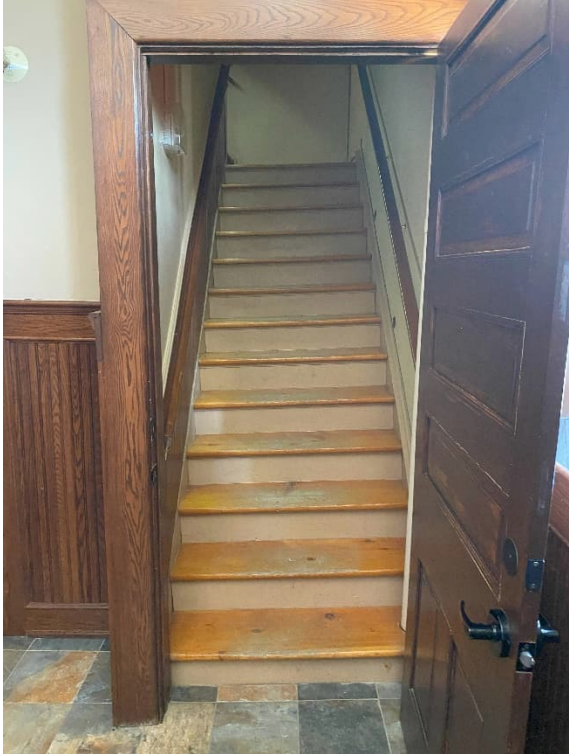
5. The stairs located at the northeast corner of the building are not level. (see Photo 21 to 22)
6. During the site visit, an open hole was noticed on the west basement wall. It can be observed that moisture and mold had accumulated on the membrane covering the stone foundation wall. (see Photo 23)

Photo 21: Unlevel Stairs at the Northeast Corner of the Building

5. The stairs are currently functioning well. However, it is recommended to monitor them regularly.
6. Moisture and mold on foundation walls can be a common occurrence. It is recommended that the existing drywall hole in the basement area be repaired by cleaning debris, patching damaged membranes, and reinstalling drywalls.

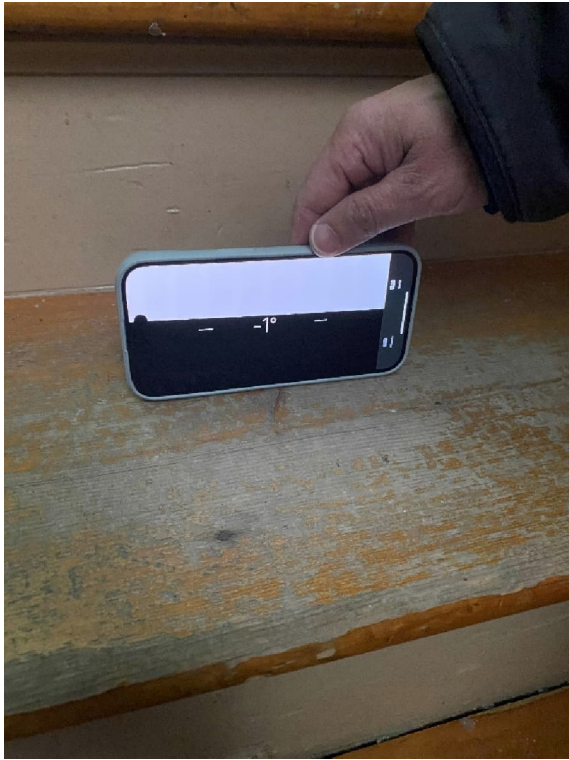
Photo 22: Slope Measurement of the Unlevel Stairs

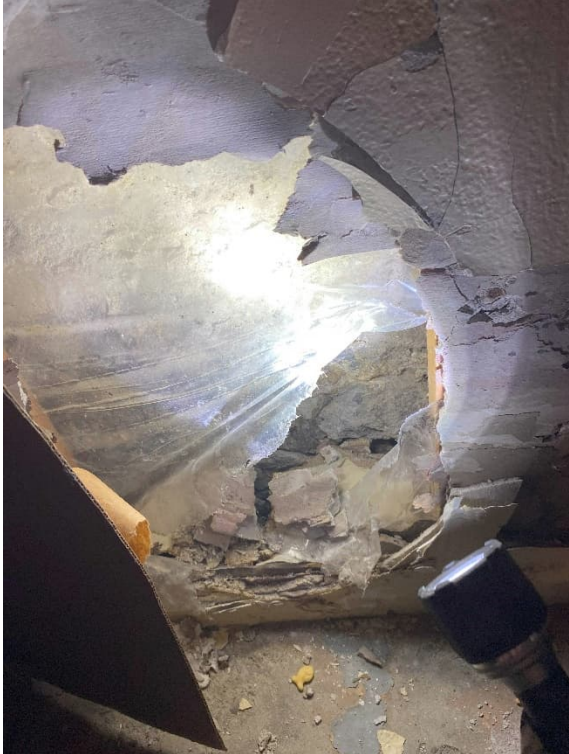
Photo 23: Exposed Foundation Wall

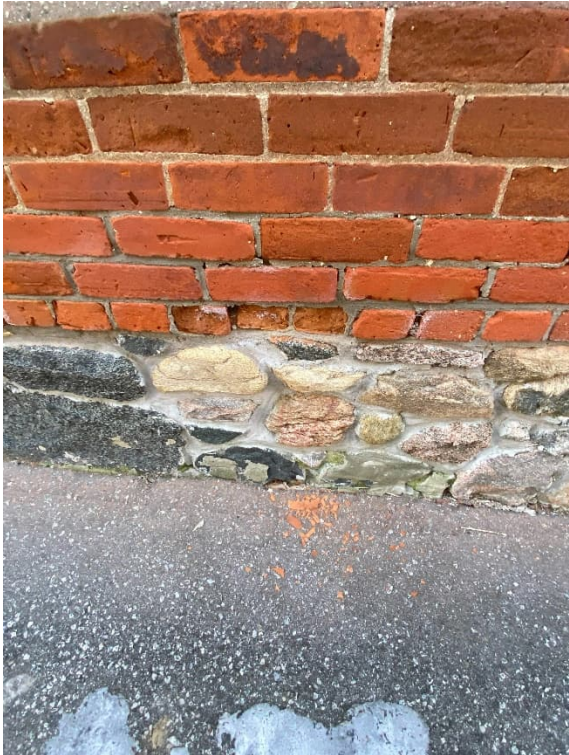
7. A visual inspection of the external brick wall was carried out. Majority of the existing brick wall has no significant change from our last inspection. Lower courses of the brick on the front face of the building have been recently repaired. However, the lower course of the brick wall on the north side has experienced significant spalling, likely as a result of snow piling and exposure to road salt. (see Photo 24)

Photo 24: Brick Spalling on North Exterior Wall

7. It is recommended that the spalling bricks near the base of the wall along the north side of the building be repaired / replaced as soon as possible to prevent further deterioration.
