Re: Summary Letter - Environmental Review

Centennial Park - 1 Centennial Park Drive, Uxbridge, Ontario

Summary Letter – Environmental Review Centennial Park – 1 Centennial Park Drive, Uxbridge, Ontario 27 January 2025

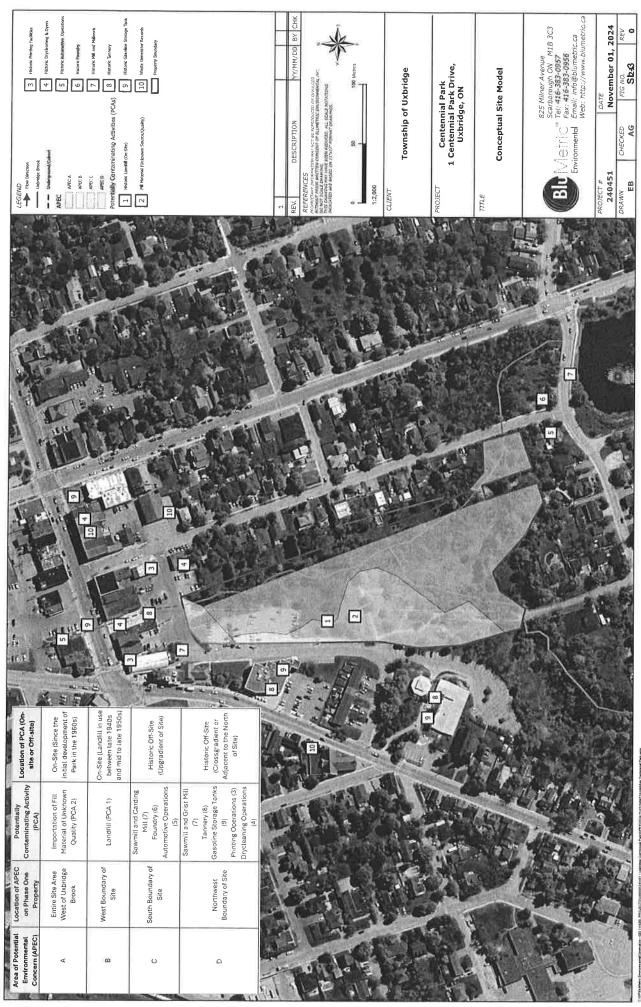
The above historic uses of the Site (i.e. landfill and importation of fill material) are potentially contaminating activities (PCAs) under Schedule D of Ontario Regulation 153/04 under the Environmental Protection Act (EPA). The Areas of Potential Environmental Concern (APECs) are shown on the attached Figure 21.

Based on the reviewed physical data, information, and records for Centennial Park and the surrounding properties, three areas of potential environmental concern (APECs) were identified on the Subject Property (See Table 6 attached). There is little available soil and ground water data on which to base an assessment of site conditions. For any proposed re-development of any area of the park, caution is recommended, and the following actions should be taken to assess the actual conditions in the proposed locations of any alteration to the park.
